URGENT SAFETY NOTICE

- Survivair Panther TwentyTwenty Plus® CBRN Facepiece nozzle found on 2420XX series facepieces.
- Survivair Panther TwentyTwenty Plus® CBRN Facepiece Air Klik found on 2420XX series facepieces.
- Survivair Panther TwentyTwenty Plus® Facepiece nozzle found on 2220XX, 2320XX, 2520XX, and 2620XX series facepieces.

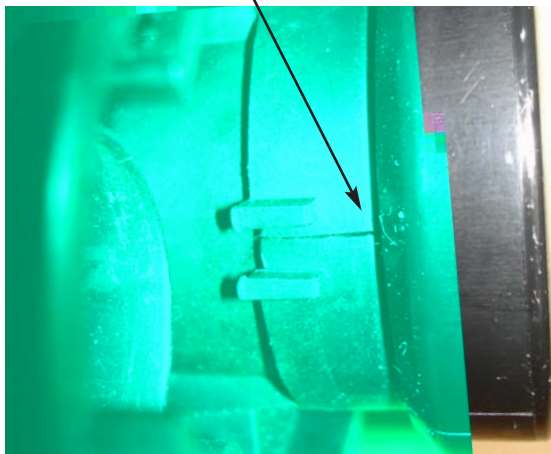
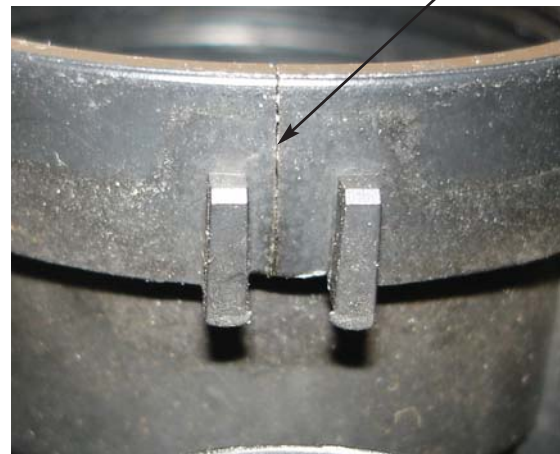
Figure 1

It has been determined that the Survivair TwentyTwenty Plus® Facepiece nozzle has the potential to crack at the molding knit line if the Air Klik is over-tightened as shown in **Figure 1**. Please note that the mold knit line as shown in **Figure 2** is normal and acceptable as long as the plastic has not cracked and separated as shown in **Figure 1**. If you are uncertain as to whether there is a normal knit line or a crack in your nozzle, attempt to spread the plastic apart. If it is a crack, the plastic will separate.

A CRACKED FACEPIECE NOZZLE MAY CAUSE AIR LEAKAGE THUS DECREASING THE RATED SERVICE TIME FOR THE AIR CYLINDER. SOME TESTS HAVE SHOWN THAT A CRACKED FACEPIECE NOZZLE MAY REDUCE THE TOTAL USABLE AIR BY A MINUTE OR MORE. FAILURE TO PROPERLY EXAMINE THE NOZZLE AND CORRECTLY PERFORM A NEGATIVE PRESSURE FIT CHECK PRIOR TO USE, MAY LEAD TO INSUFFICIENT BREATHING AIR DURING USE WHICH MAY LEAD TO SERIOUS INJURY OR DEATH.

Crack spread open due to over-tightened Air Klik

Crack without Air Klik

It is possible that the Air Klic in your CBRN facepiece may have been over-tightened at the factory during the production process. Since it is not possible to know if your Air Klic was over-tightened, we are advising all users of CBRN facepieces to replace the nozzle and Air Klic in their facepiece with a new nozzle and Air Klic as described below and provided in kits available from Survivair.

Inspect your 2420XX series facepieces to see if they have a crack in the nozzle as shown in **Figure 1**. If any of the facepieces have a crack in the nozzle as shown in **Figure 1**, remove them from service and replace the nozzle with a new modified nozzle and Air Klic prior to returning the facepiece to service. If any of your 2420XX facepieces **DO NOT** have the modified nozzle as shown in **Figure 3**, and **DO NOT** have a crack in the nozzle as shown in **Figure 2**, they may be put back into service temporarily, but only until the nozzle can be replaced with a new modified nozzle and Air Klic. Contact Survivair by fax using the attached Fax Form to receive nozzle and Air Klic replacement kits.

Survivair advises all users of Panther TwentyTwenty Plus® Facepieces, series number 2220XX, 2320XX, 2520XX, and 2620XX, that if your facepiece fails a negative pressure fit check, inspect the nozzle for a crack as shown in **Figure 1**. Survivair will replace all cracked nozzles under warranty regardless of purchase date. Contact Survivair by fax using the attached Fax Form to receive replacement nozzle kits.

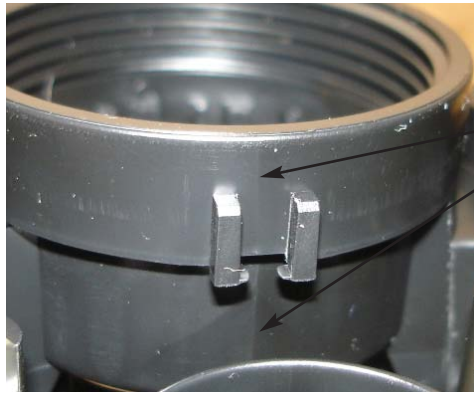
Figure 2

Normal knit line (note: no visible separation)

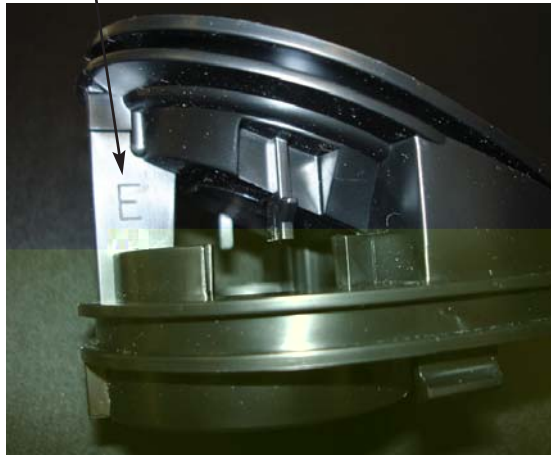
Figure 3

Modified nozzles have an "E" marked on the web as shown

Please inspect your 2420XX series facepieces to see if they have the new, modified nozzle as shown in **Figure 3** (the nozzles are marked with an "E" as shown) and the correct CBRN Air Klic as identified in **Figure 4**. If your facepieces have the modified nozzle as shown in **Figure 3**, and correct Air Klic as shown in **Figure 4**, these parts do not need to be replaced, and you may return the facepieces to service.

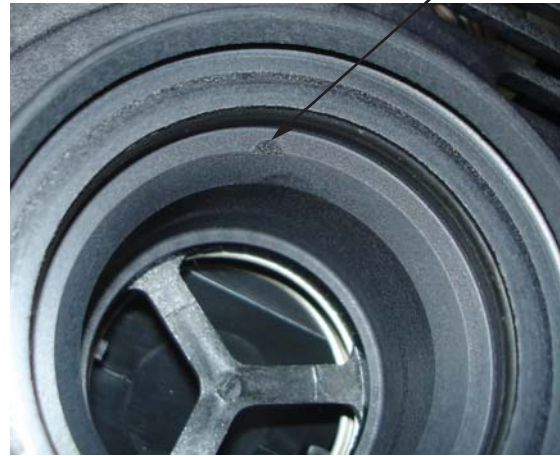
Figure 4

Survivair has also received at least one report of the second stage regulator being difficult to install into the CBRN facepiece. An investigation of that report revealed that the o-ring groove on the facepiece Air Klic was machined slightly shallow. This combined with the stiffness of the EPDM o-ring material used in the CBRN version of the Air Klic, made the regulator slightly more difficult to install into the CBRN facepiece than in the non-CBRN facepiece. Current facepieces have Air Klics with the correct o-ring groove diameter. These Air Klics are marked with a half-moon shaped visible identifier when looking at the front of the Air Klic. See **Figure 4**.

Half-moon shaped Air Klic identifier
